**Coastal Protection and Restoration
Authority of Louisiana (CPRA)**

2017 Operations, Maintenance, and Monitoring Report

West Belle Pass Barrier Headland Restoration (TE-52)

August 2017
Lafourche Parish

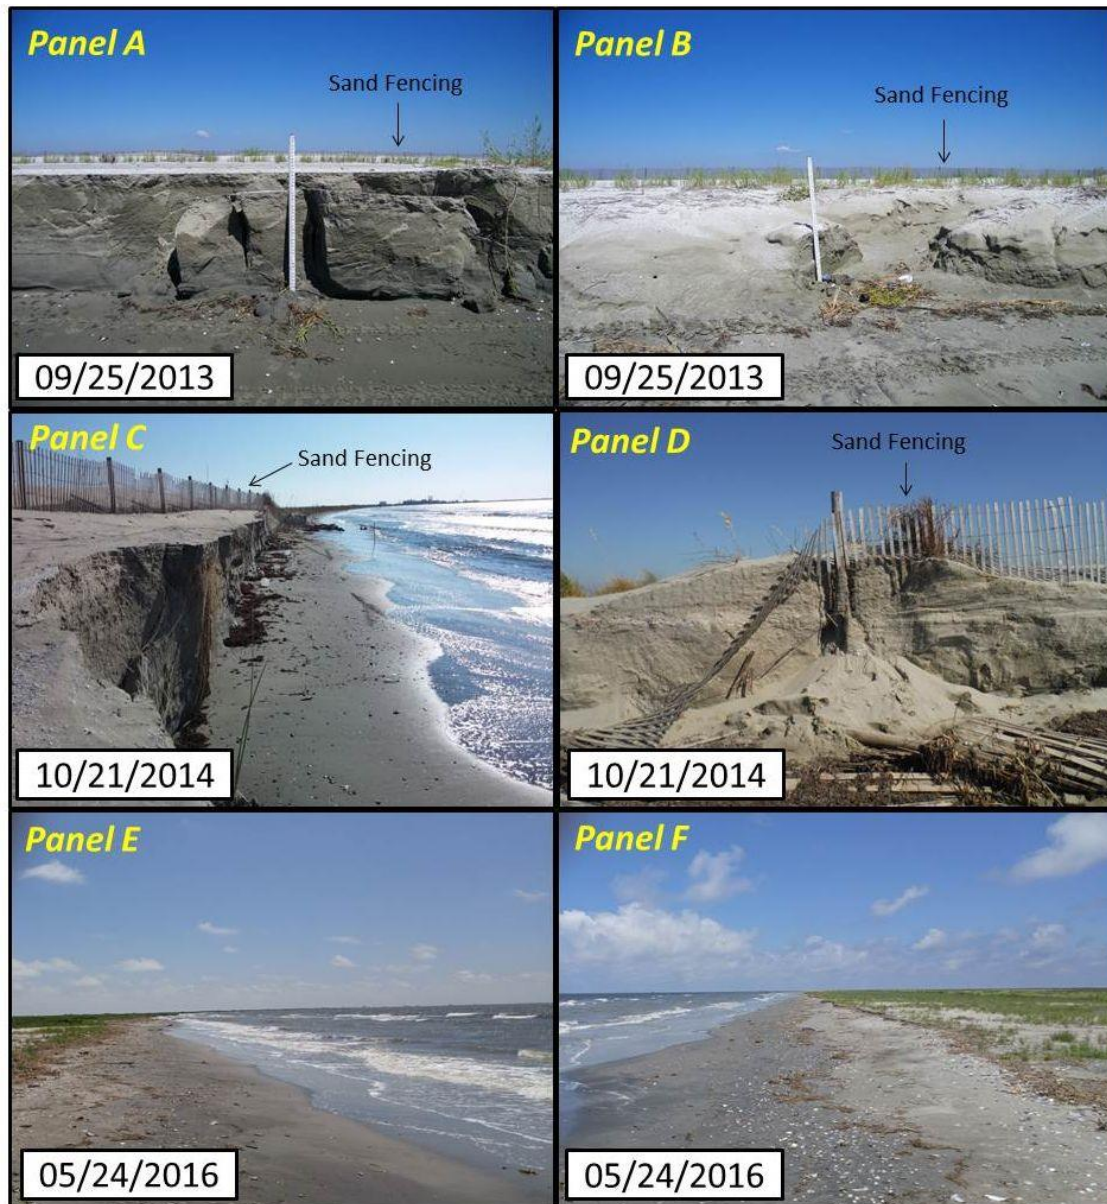
Figure 23. The oblique images above depict scarping and leveling of the TE-52 project's dune feature in 2013, 2014, and 2016. Note the severe scarping that occurred several months after construction and the distance to the sand fencing in 2013 (Panels A and B). Panel B also shows channel formation during high water events along the eastern reaches of the dune feature. Several channels formed on the supratidal elevated expanded beach and dune template. Panels C and D display the steep edges of the remaining dune and sand fence deterioration. The sand fencing was placed in the center of the dune, so half of the dune form has been removed from panels C and D. By 2014 the dune feature along the eastern reaches of the project no longer exists. Panel C also illustrates a very narrow beach. These short beaches are typically the cause of sheer dune formations. Panels E and F exhibit washover and dune terrace landforms. By 2016 no dune feature exists parallel to the Gulf except the offset dune while the northwestern dune remains intact. Sand fencing only remains in these two areas.

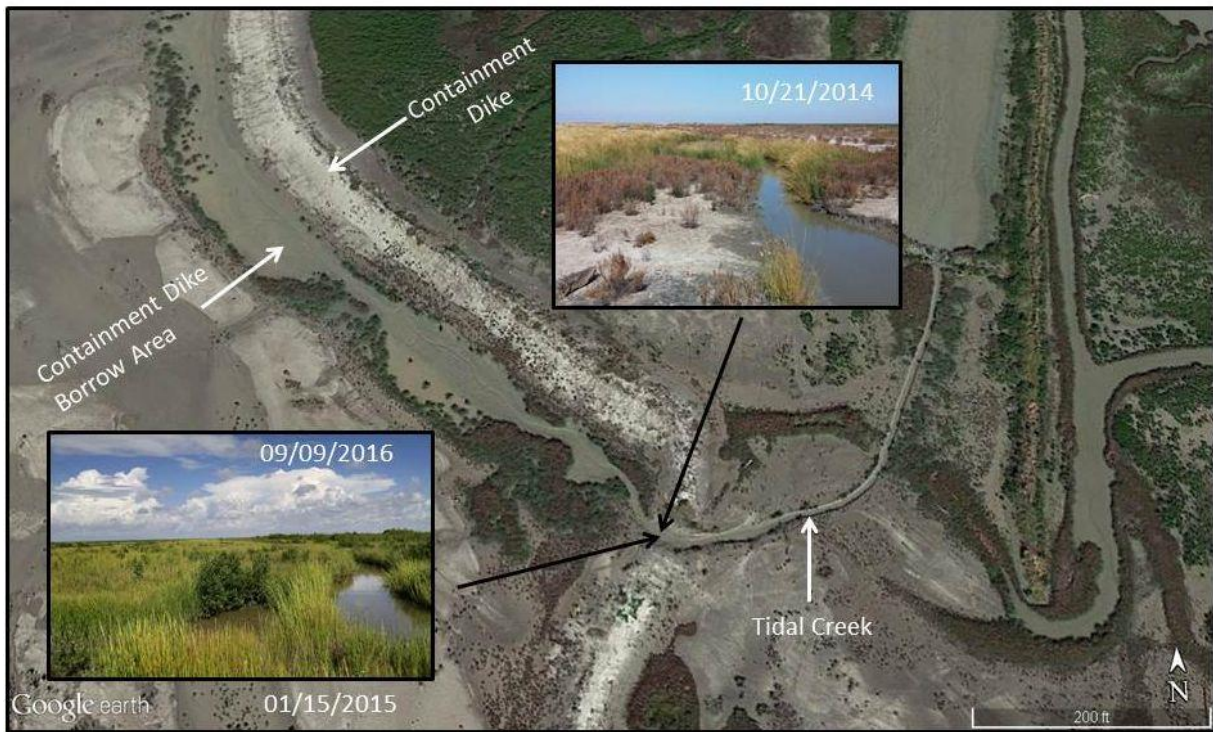
Figure 33. Jan 2015 Google Earth image and Oct 2014 and Sep 2016 oblique images depicting tidal connectivity and vegetation colonization through the gapped containment dike at the West Belle Pass Barrier Headland Restoration (TE-52) project. Note the vegetation colonization along the edges of the low elevated containment dike borrow area.

Several improvements would enhance the sustainability and increase habitat utilization of the West Belle Pass Barrier Headland Restoration (TE-52) project. The first recommendation to gap the primary containment dike is already slated to be constructed in the fall of 2017. The dike will be gapped in three locations during this event. Gapping of this dike will improve tidal exchange between Timbalier Bay and the marsh platform. This event should support the spring 2017 plantings in the marsh creation area, enhance the connection to the daily tidal cycle, and increase the acreage of functioning saline marsh habitat. Currently the marsh platform consists primarily of salt flat habitat. Two recent back barrier marsh creation projects have vegetated after tidal connectivity was established. Moreover, vegetation has colonized the creation area marshes adjacent to the gapped section of the containment dike and along the containment dike borrow area because of tidal creek formation. Therefore, it is highly likely that the TE-52 marsh creation area will vegetate when tidal connectivity is enhanced.

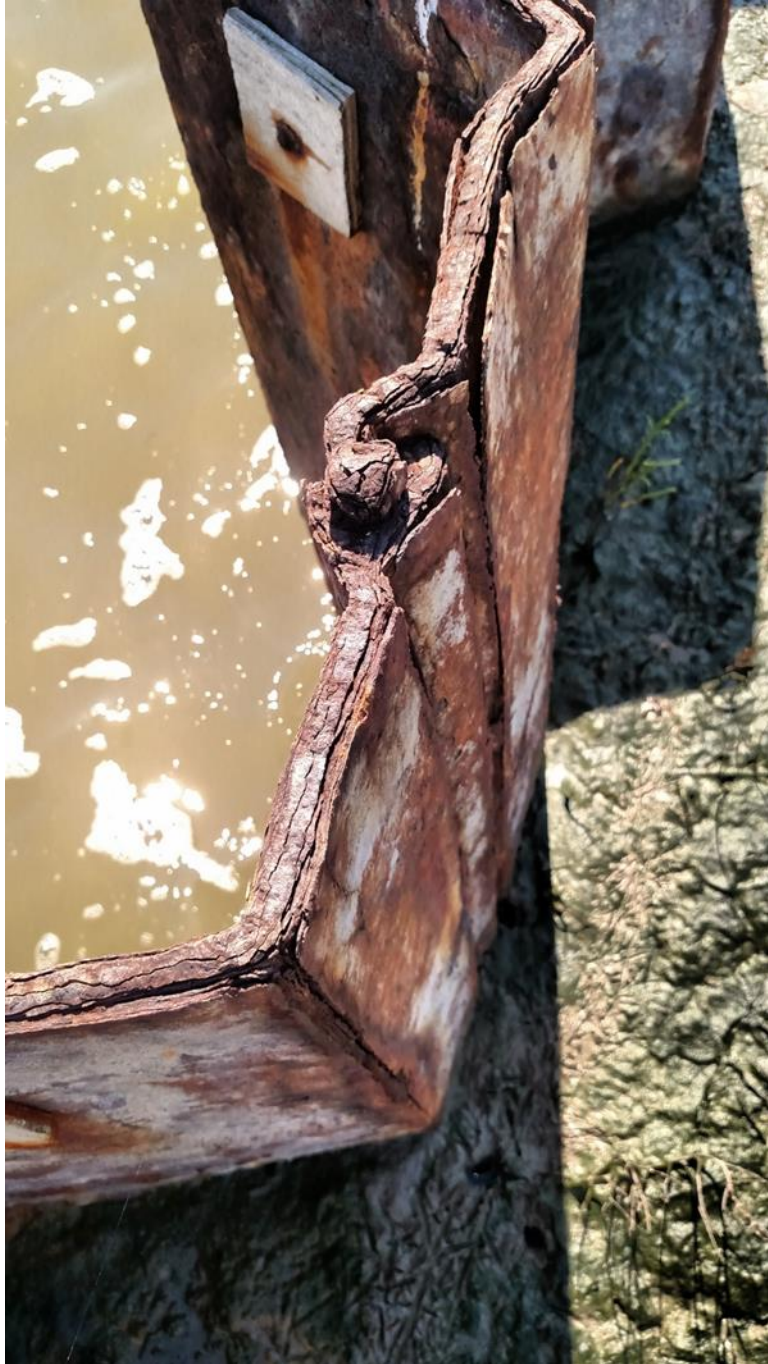
Photo A-1. View of sheet pile condition in northern containment dike.

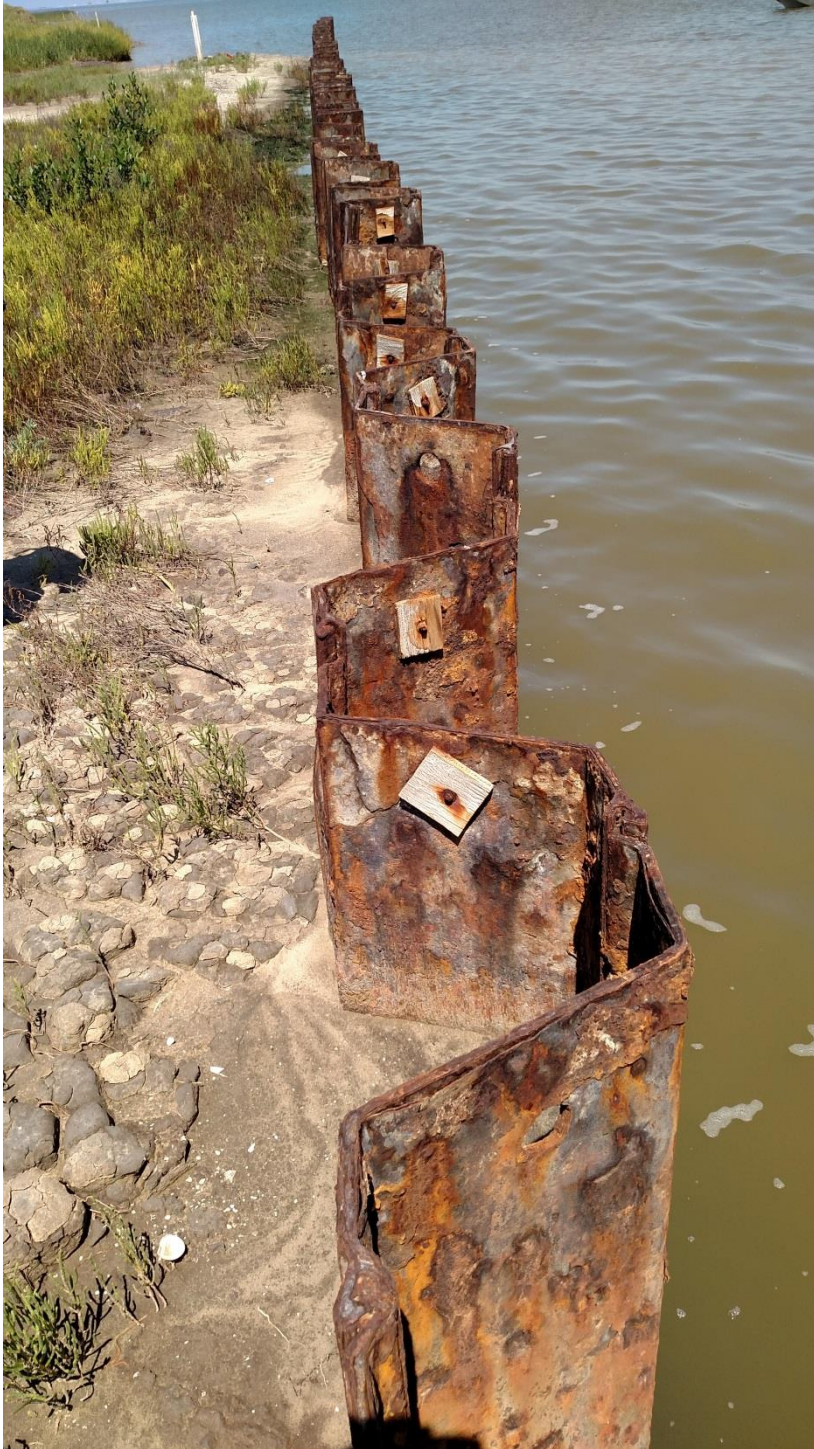
Photo A-2. View of sheet pile plug in northern containment dike, looking west.

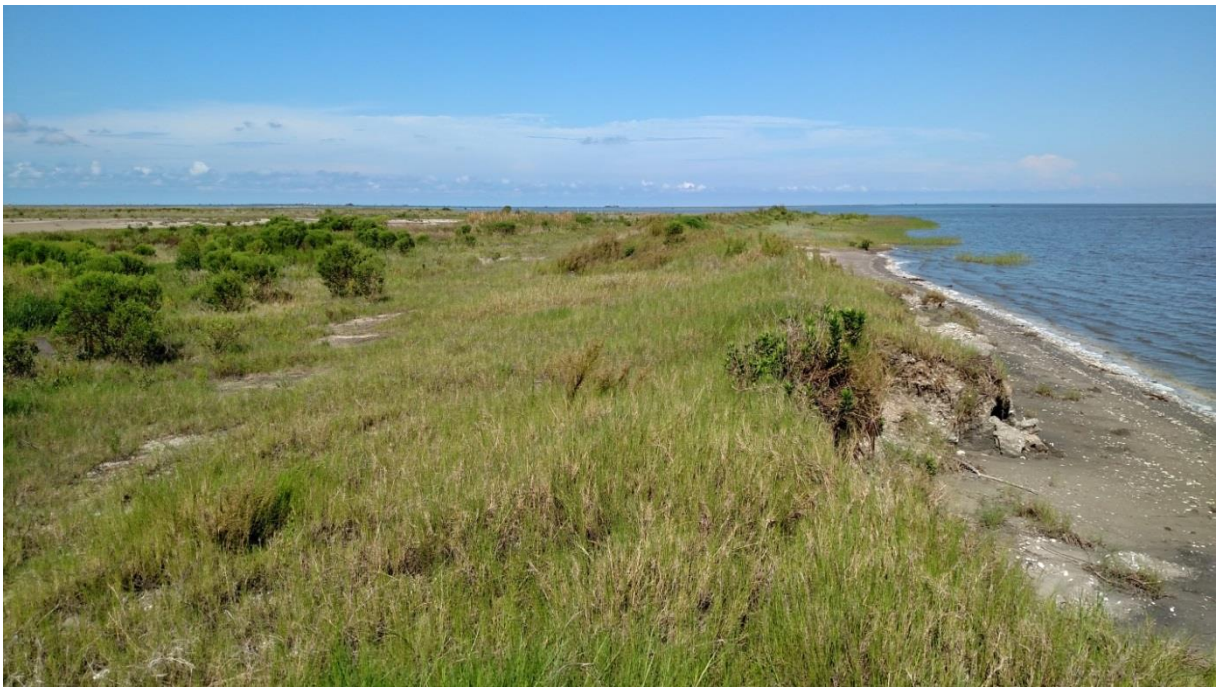
Photo A-4. View of northern primary containment dike west of sheet pile wall.

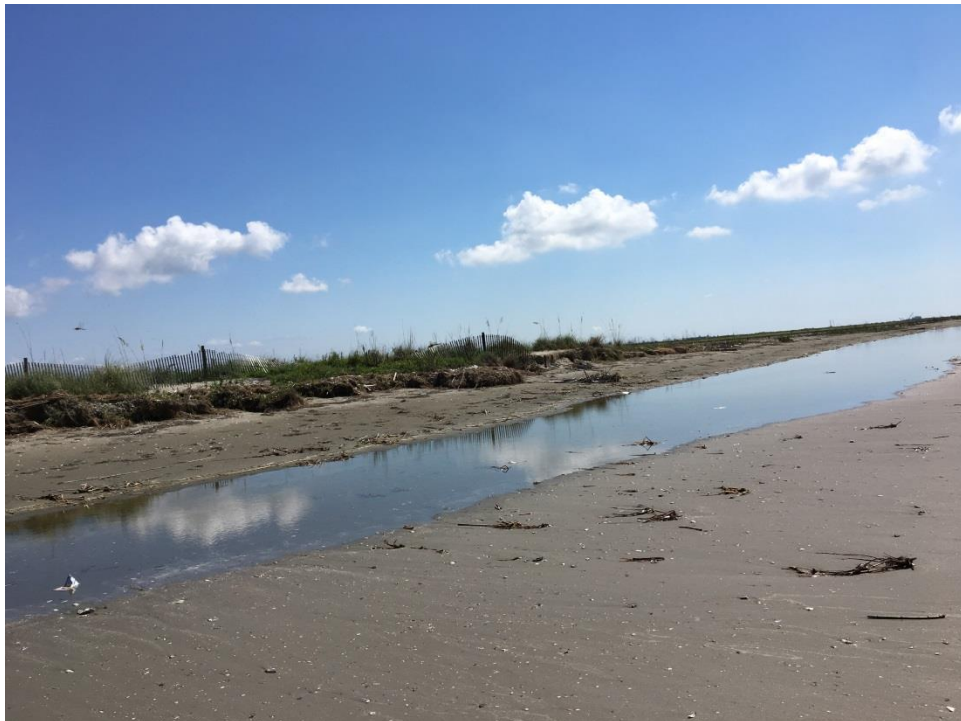
Photo A-12. View of dune erosion and damaged sand fencing.

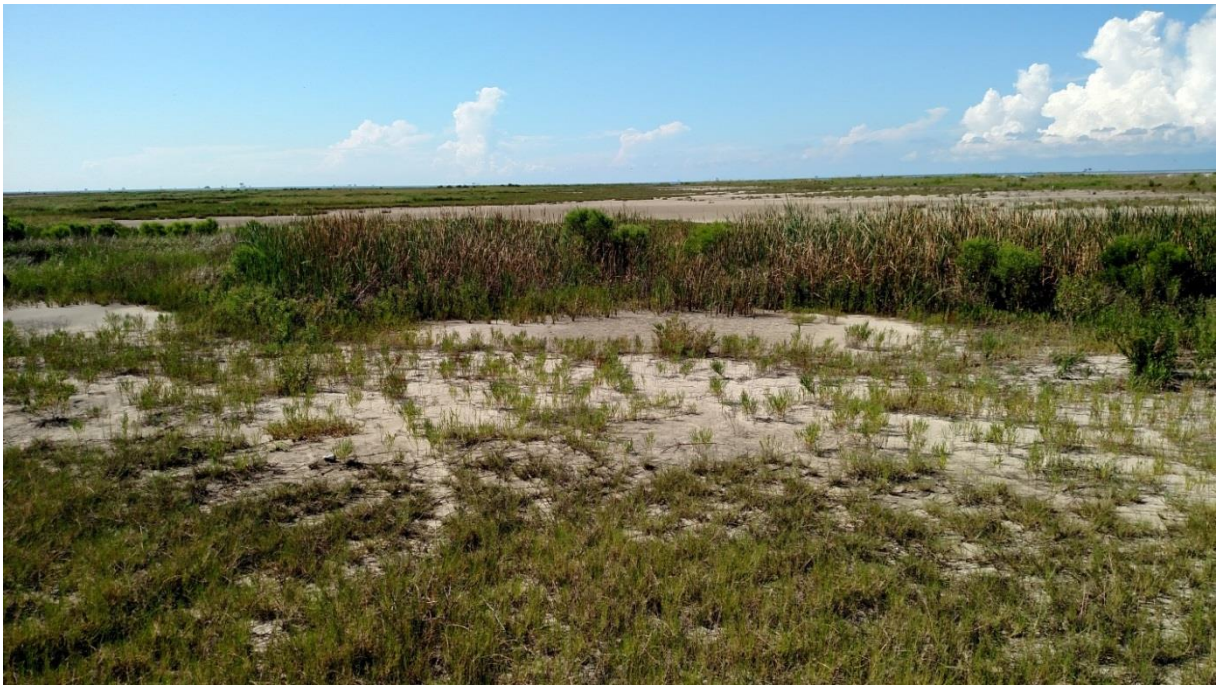
Photo A-14. View of remaining non vegetated section in center of marsh platform, on the western edge of project.
